Seismic Performance and Retrofitting of Steel Building

Bulbul Ahmed*, **S. M. Zahurul Islam**

Department of Civil Engineering, Rajshahi University of Engineering & Technology, Rajshahi, Bangladesh

Bulbul Ahmed, S. M. Zahurul Islam. Seismic Performance and Retrofitting of Steel Building. *Industrial Engineering*.

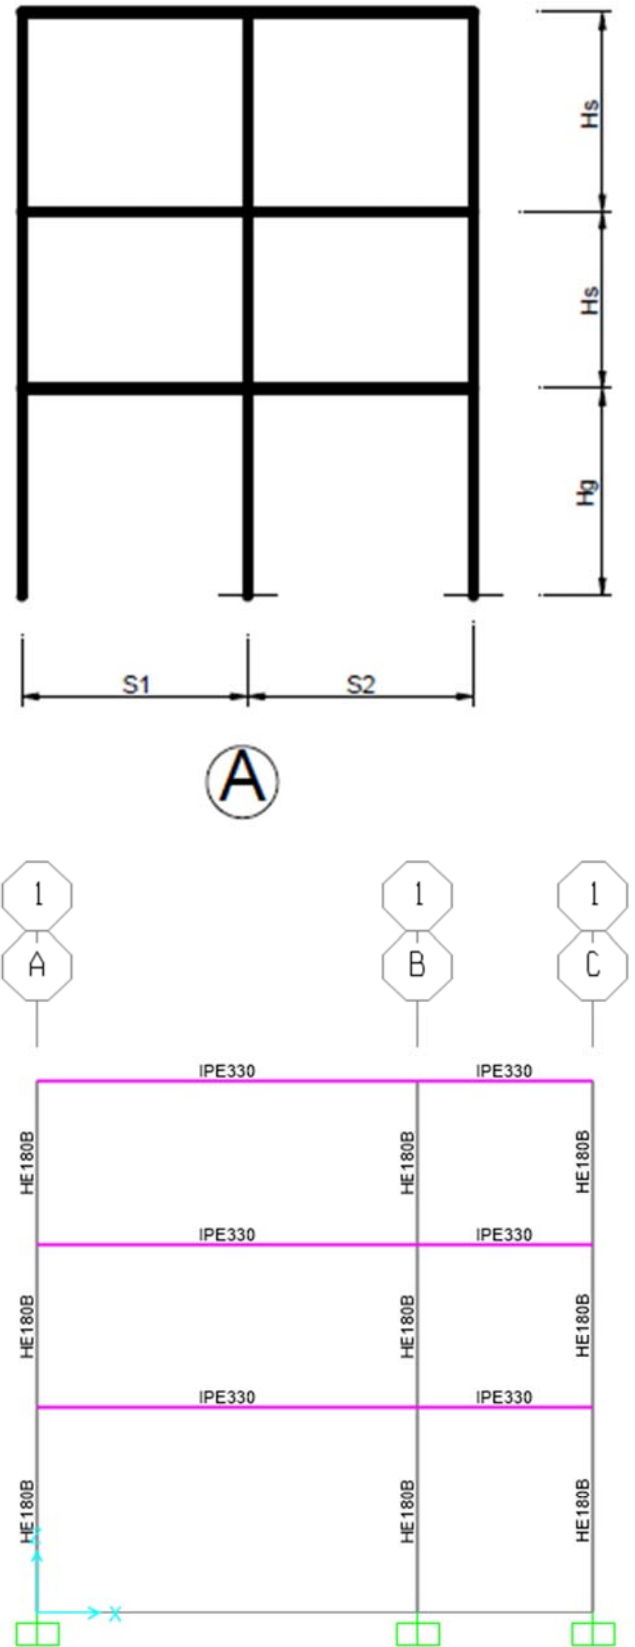
Figure 1. Structural model of the steel building.

The building is considered for this research is three storey office building. The location of the building is in Timisoara, Romania. First span of the building is 6.5m and second span is 3.0m. Bay distance is 5m and the storey height from the bottom is 3.5m, 3.0m and 3.0m respectively. The soil type of that area is B and the peak ground acceleration (PGA) is 0.16g. European steel cross section HEB 180 and IPE 330 was used for the columns and primary beams respectively. Gravity load acting on the structure consists of permanent load 4.88 kN/m^2 for roof slab and 3.70 kN/m^2 for floor. Live load 3.0 kN/m^2 acting on the floors and no live load acted on the top floor. Live load for external and internal wall 1.0 kN/m^2 and this live load also acts on the floor only. Snow load for the roof slab is 2.5 kN/m^2 but its not acted on the other floor. Structural model of the building is shown in Figure 1.

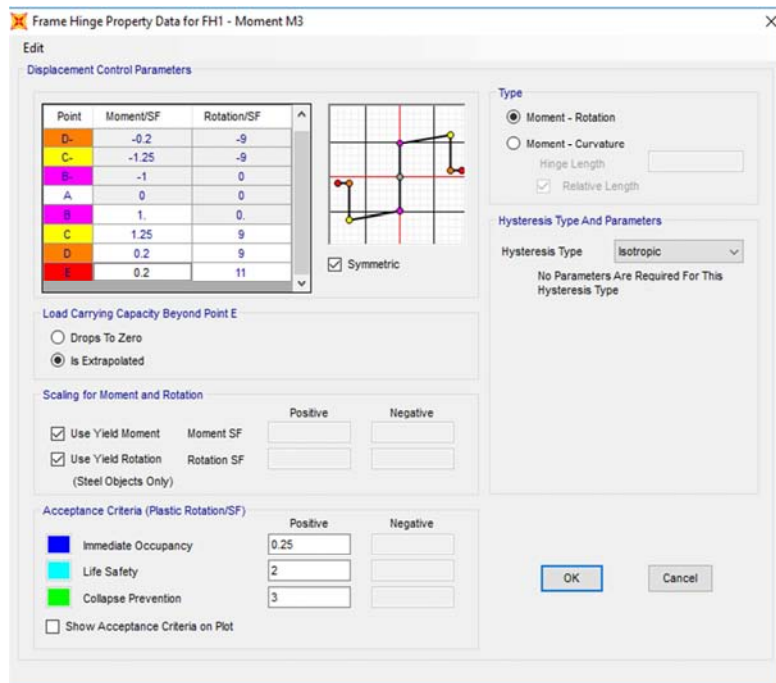
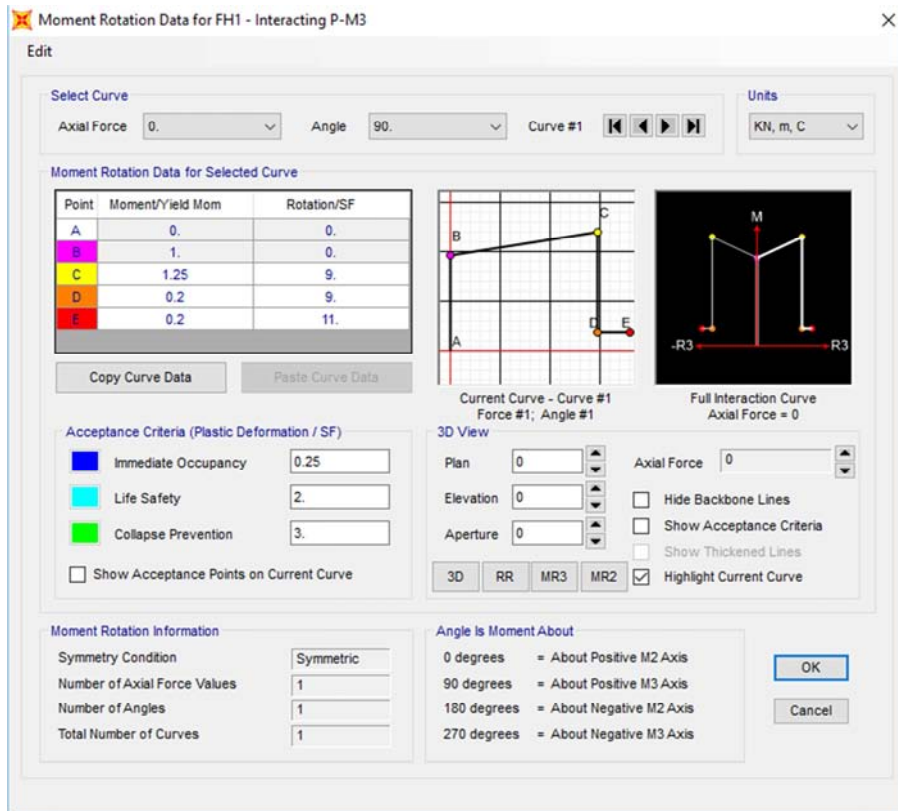
Figure 2. Properties for push over analysis

The plastic hinges formation of the beams and columns are shown in the figure 2. For the beams plastic hinges type M and for the columns it is P-M. There are two methods for controlling the push over analysis. Force control that is done for the gravity load and lateral force is considered as displacement controlled. For both forces controlled and displacement controlled it is nonlinear static analysis. The lateral forces are calculated from the gravity load acting on the structures. For this frame calculated lateral forces are presented in the figure 4.

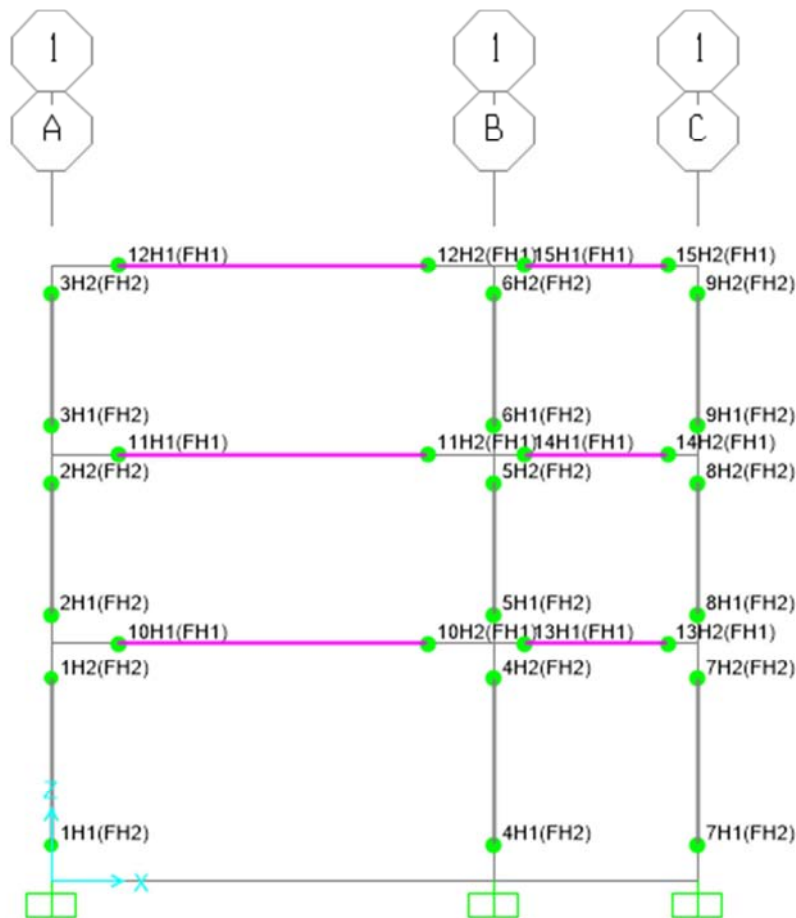
Figure 3. Hinge assignment to members.

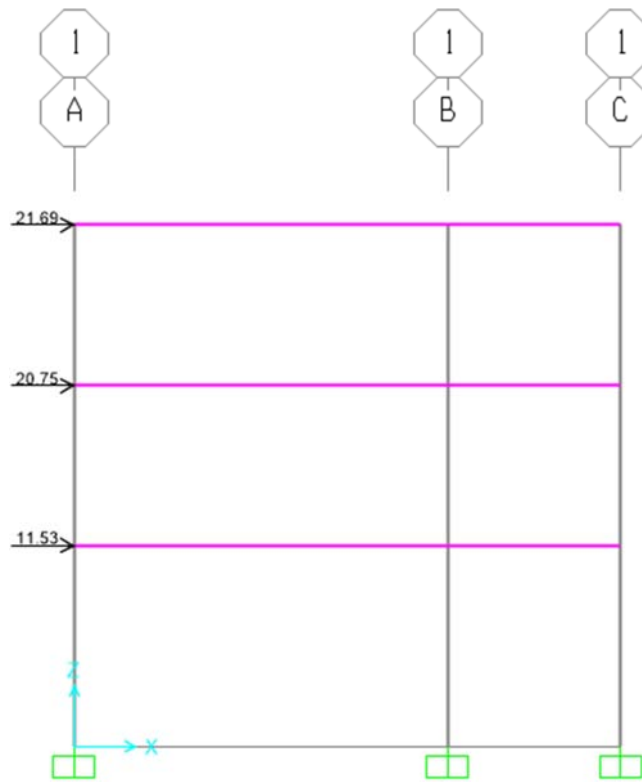
Figure 4. Lateral forces acting on each floor.

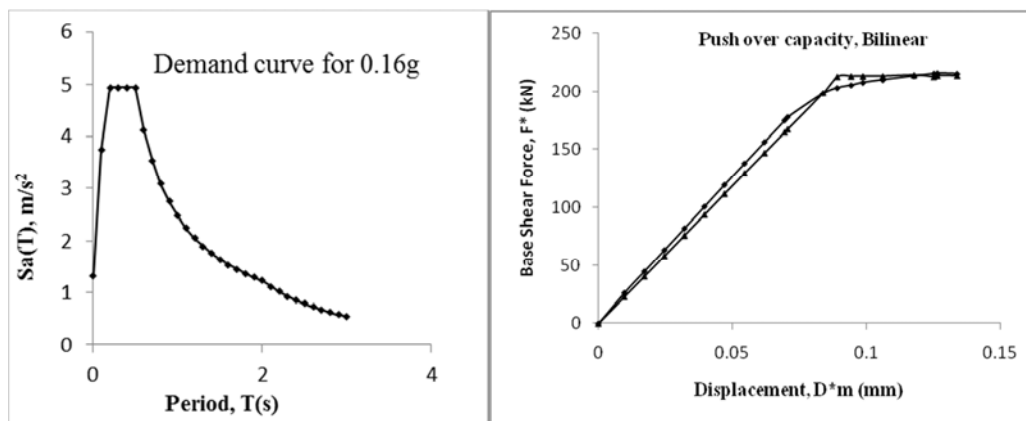
Figure 5. Push over capacity-demand curve for target displacement (PGA = 0.16g).

The capacity demand curve found from the push over analysis for calculating the target displacement is shown in figure 5. The peak ground acceleration is calculated for six different return periods. Using the recurrence formula for

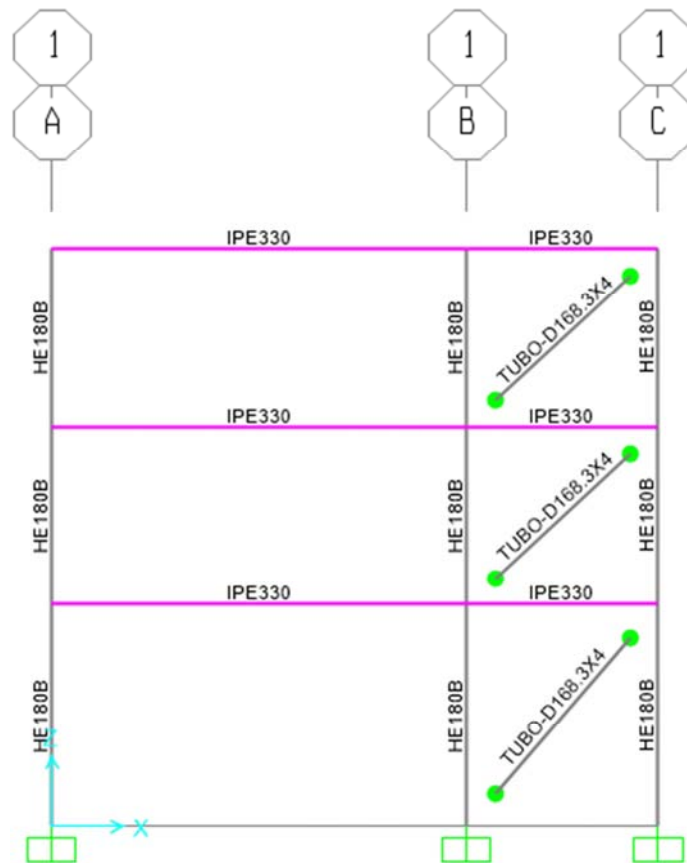
Figure 6. Structural model with diagonal bracing.

occur in columns [11]. The bracing size used is TUB-168.3x4 mm in the direction of tension and using pushover analysis for the Life Safety performance level under an earthquake hazard level with 10% probability of exceedance in 30, 50, 100, 225, 475 and 975 years. The analysis of the 3D frame structure is done using software SAP 2000. The structural model with diagonal bracing is shown in figure 6. Plastic hinges identified for retrofitted structure is shown in figure 7.

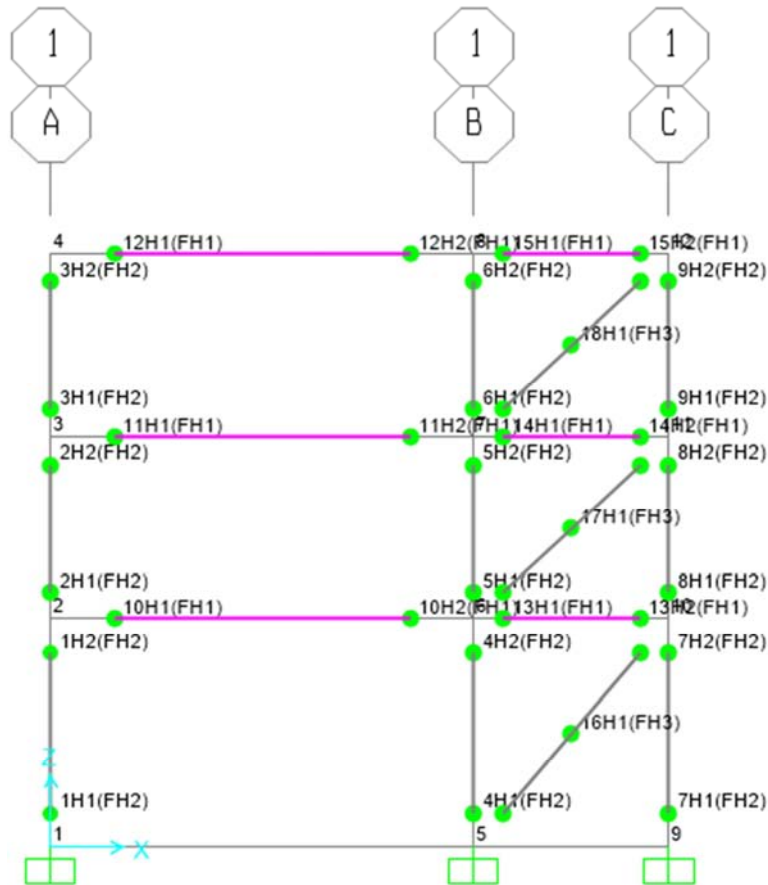
Figure 7. Hinge assignment to members.

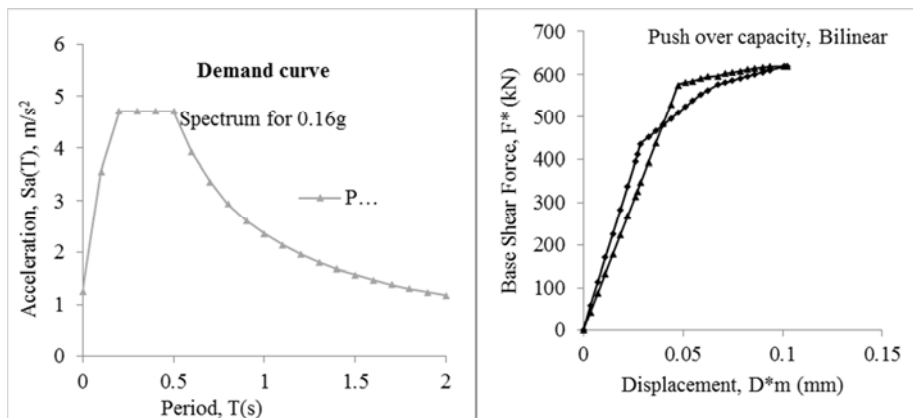
Figure 8. Push over capacity-demand curve for target displacement (PGA = 0.16g).

The capacity-demand curve after introducing the diagonal bracing increased from the push over analysis for calculating the target displacement is shown in figure 8.

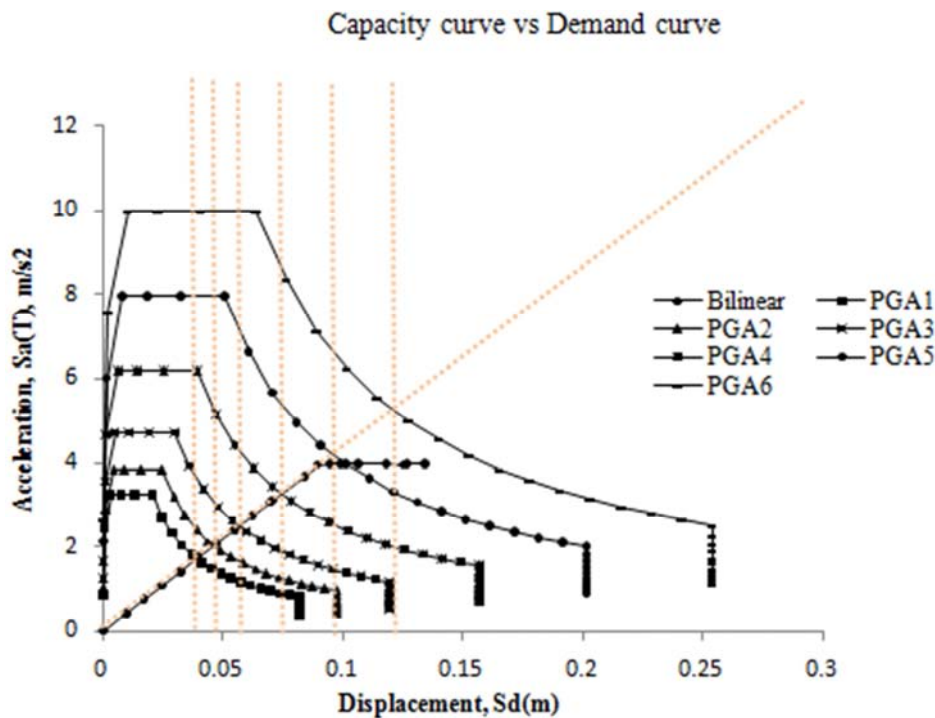
Figure 9. Capacity-demand curve of initial structure.

SAP2000. The bilinear capacity curve for the initial structure cut all demand curves. It indicates the demand curve is much more higher than the capacity curve. The initial structure is not strong enough to withstand seismic action. The comparison of capacity-demand curve is shown in figure 9. The maximum lateral displacement of the structure is 0.13m for 0.34g with respect to capacity curve.

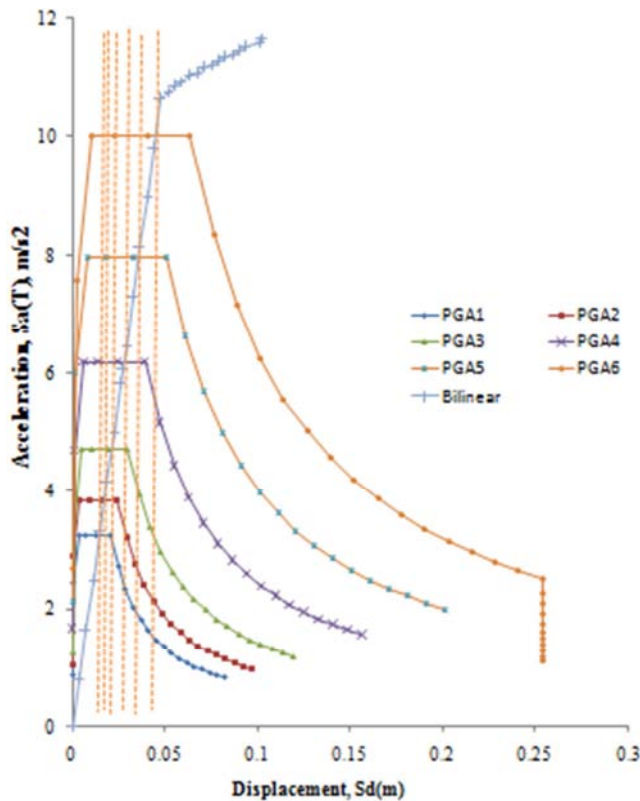
Figure 10. Capacity-demand curve of retrofitted structure.

The initial structure is retrofitted by providing the diagonal bracing in tension zone to increase the seismic performance. After providing the bracing the capacity curve of the retrofitted structure is higher than the demand curve for all kinds of peak ground acceleration. The comparison of

capacity-demand curve is shown in figure 10. The lateral displacement in between 0.01 and 0.04m for the peak ground acceleration.

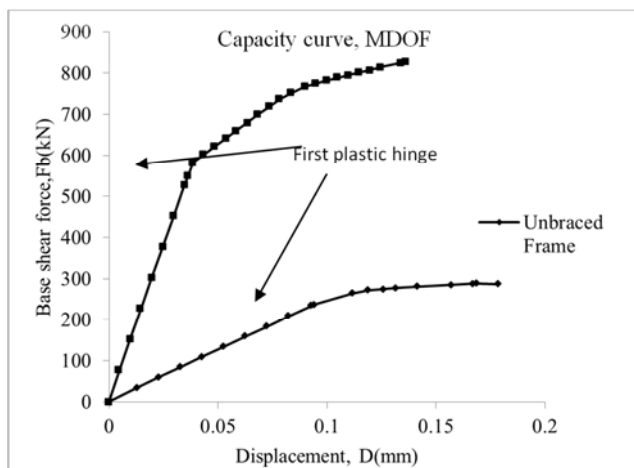
Figure 11. Comparison of capacity curve of the initial and retrofitted structure.

The comparative study of the capacity curve for unbraced and braced frame is presented in figure 11. The curve of braced frame is much higher than that of unbraced frame. First plastic hinge mentioned in the figure has formed at 0.09m of lateral displacement for unbraced frame. The plastic hinge started from 0.025m for the braced frame.
